ARBORIST REPORT-

Tree Inventory & Preliminary Impact Assessment
Atkinson Lane & Brewington Avenue, APN 048-221-09 & 091-236-01

Watsonville, CA

March 4, 2020

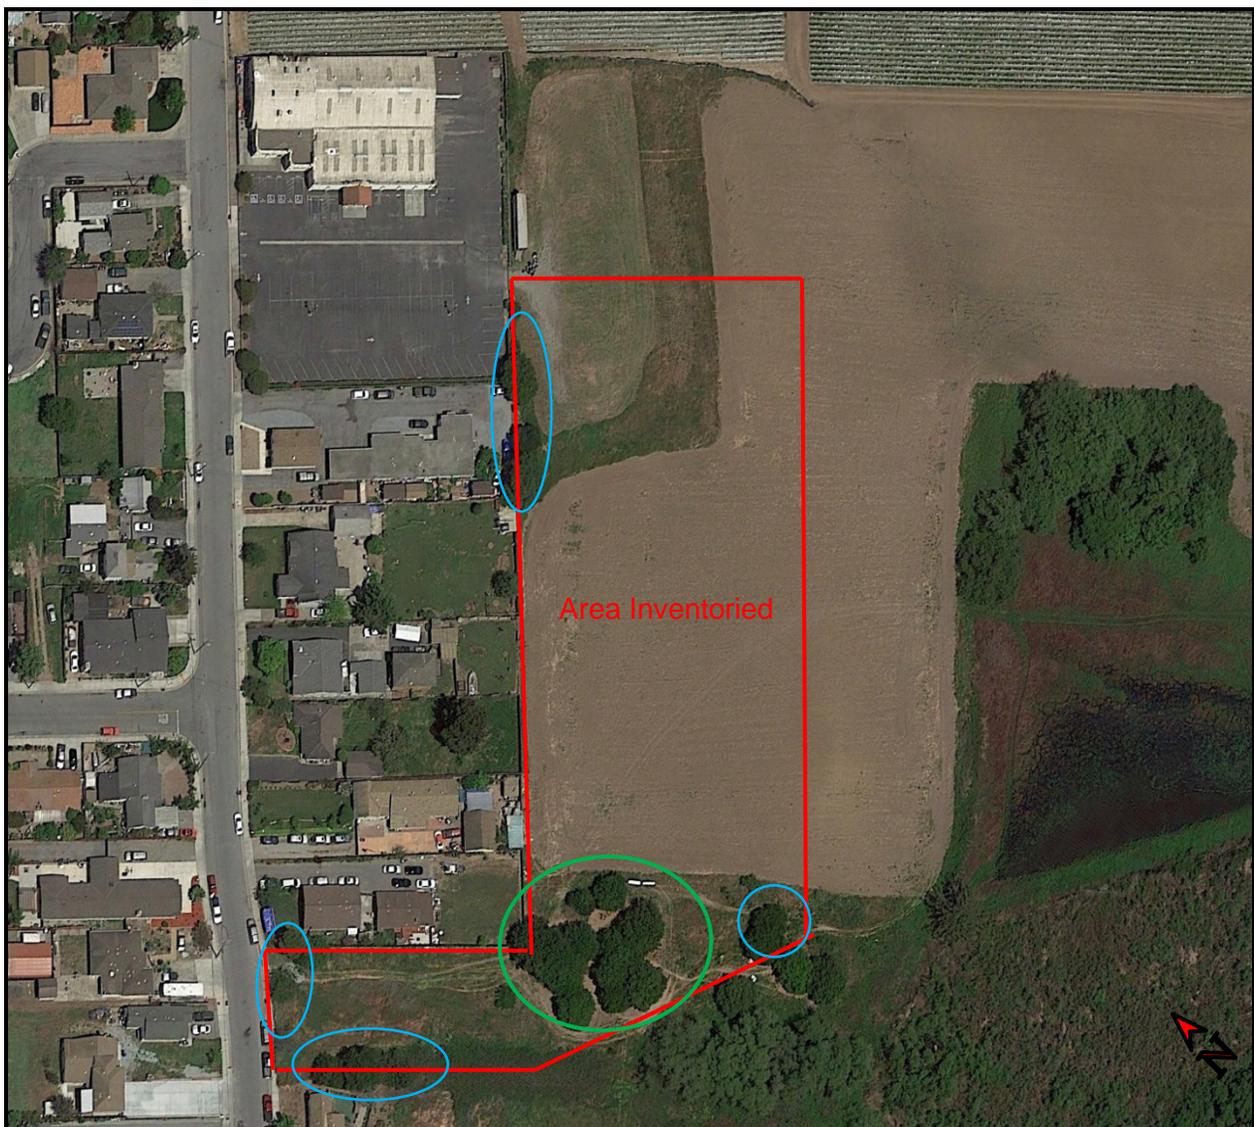
Most of the protected trees inventoried were in a grove, sited on a 20-25 degree west facing slope. The grove is composed of coast live oak trees (*Quercus agrifolia*). A few oaks were also located in a row near the property line, on the flat area above the slope. Three trees located adjacent to Atkinson Lane included, purple robe locust (*Robina* 'Purple Robe') and glossy privet (*Ligustrum lucidum*). Three coast live oaks on the western edge of the Atkinson Lane parcel were also inventoried, (Image #1).

Image #1 – Most of the trees inventoried are in a grove of coast live oak (circled green). Other trees inventoried are shown (circled blue).

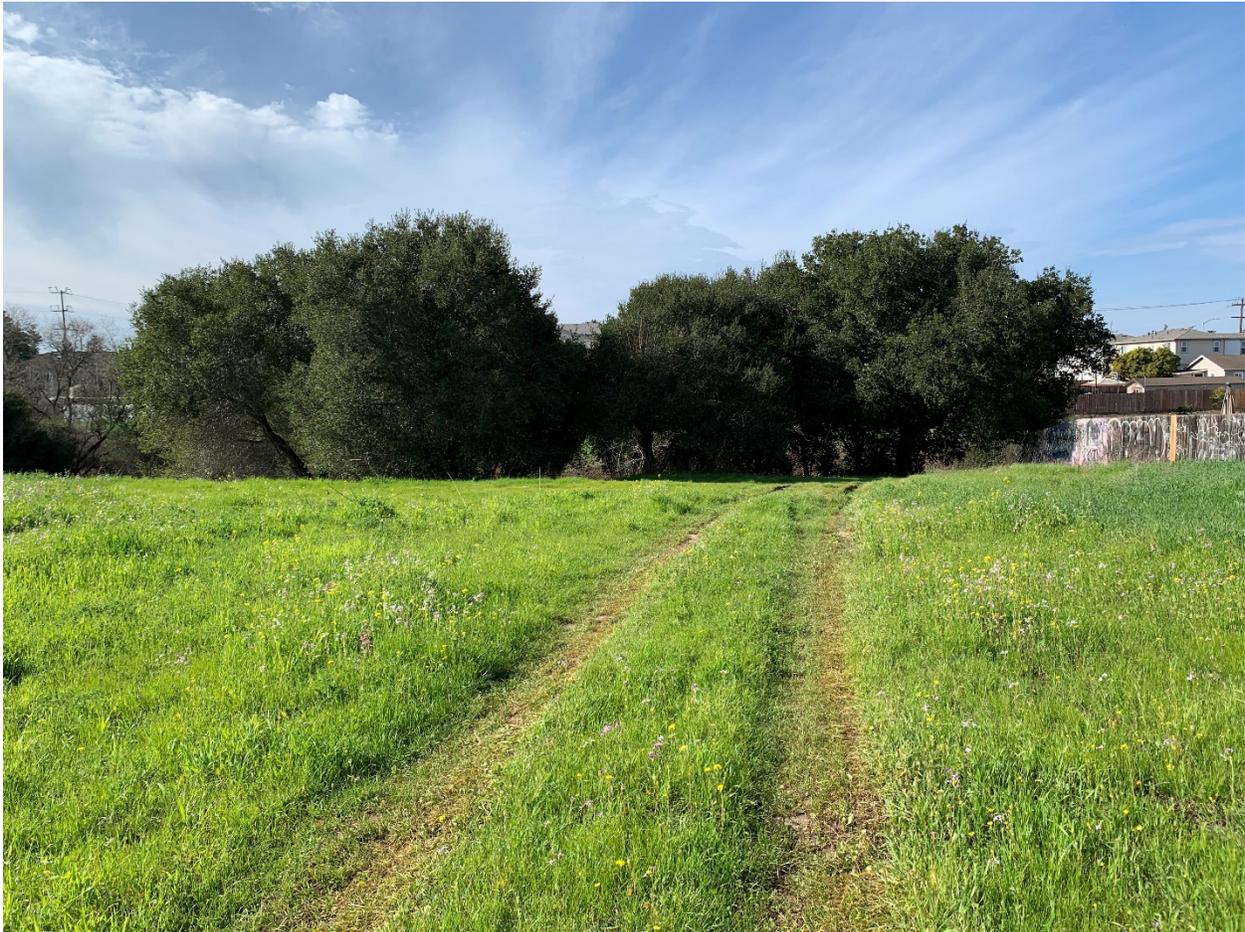
Most of the oaks in the grove are in fair condition, a few were in poor condition. Growing conditions for the oaks was good, with ample rooting area and a moderate amount of leaf litter for moisture retention. However, the trees are closely spaced within the grove and most had reduced foliar canopies since they receive less sunlight, resulting in a fair or poor condition rating for most trees, (Images #2 & #3).

Image #2 - The grove looking southwest. The grove forms a continuous canopy due to closely spaced trees.

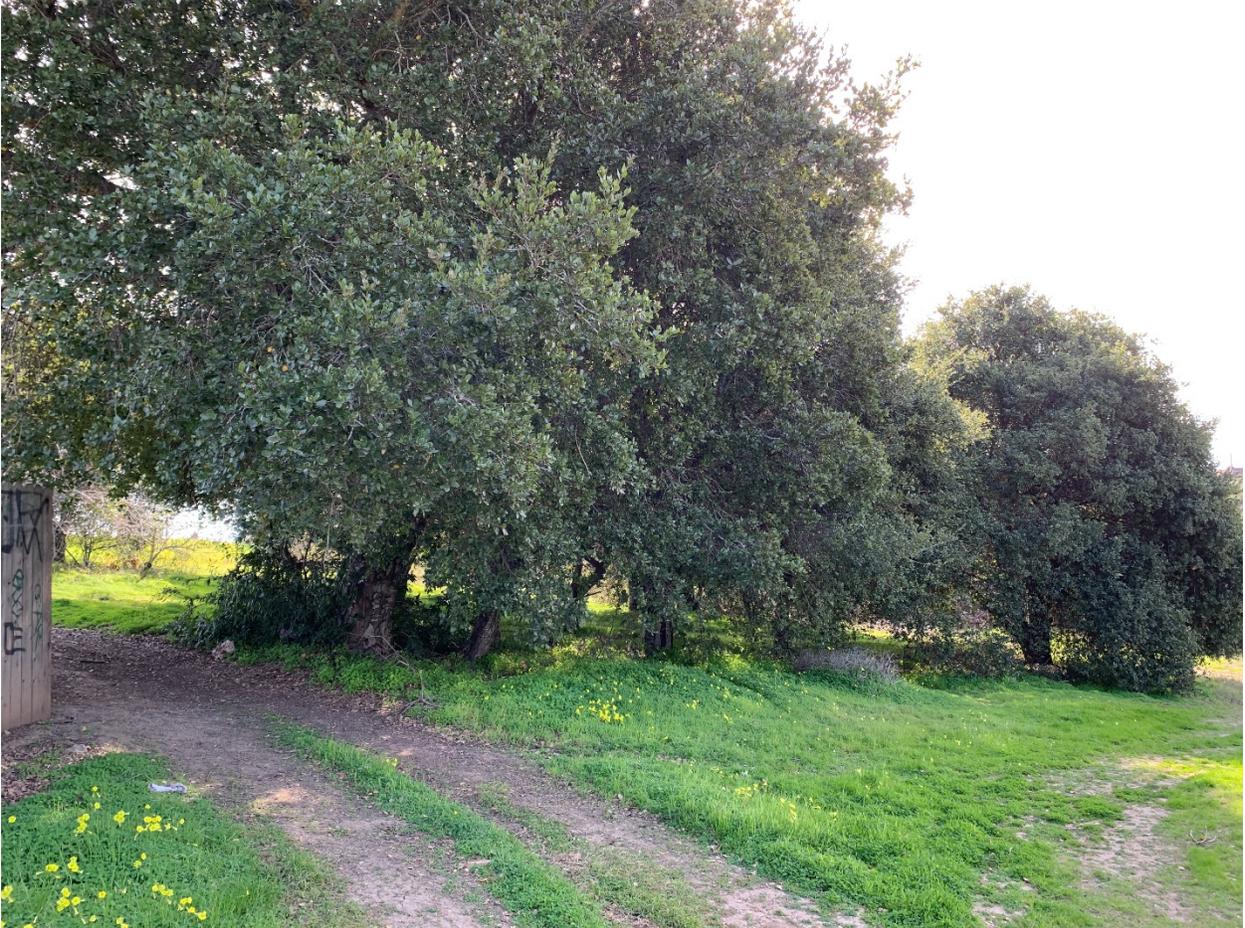
Image #3 – Western edge of grove. Note tightly spaced trees.

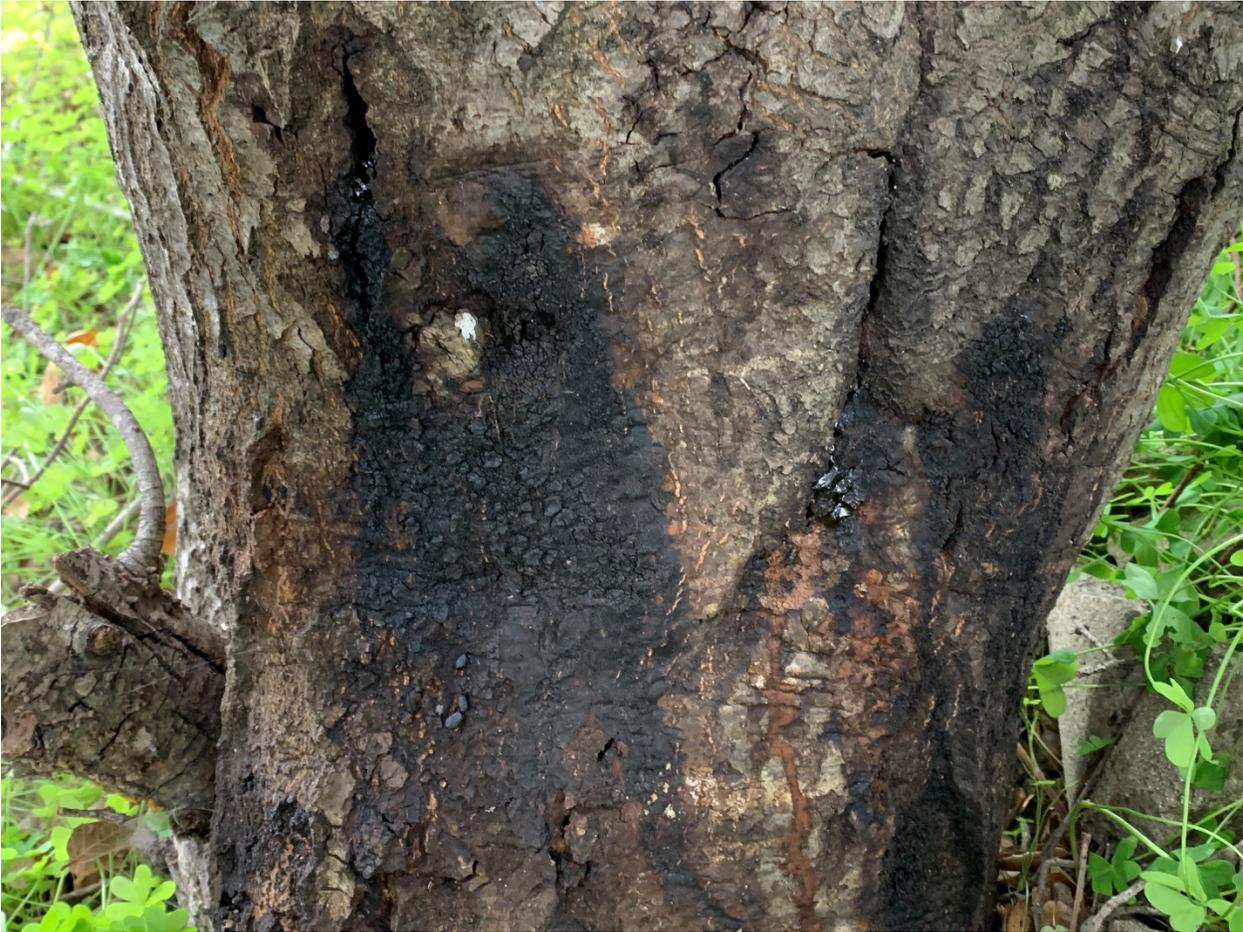
A few of the oaks in the grove (three), have signs of wood decay fungi, as evidenced by bleeding areas in the lower trunks, (Image #4).

Image #4 - Tree T63, coast live oak with multiple areas of trunk bleeding.

Three coast live oak trees T55, T63 and T64 have bleeding in the lower trunk area. A fungal pathogen is suspected for causing the bleeding symptoms. Two of these trees are in fair to poor health due to minimal foliar canopies. It is not conclusive whether the thin canopy is due to overcrowding or fungal infection decline. Positive identification of the species would require sampling and laboratory testing as a first step to treatment and is not recommended since treatments have limited success in mature trees and infections are usually not spread from tree to tree.

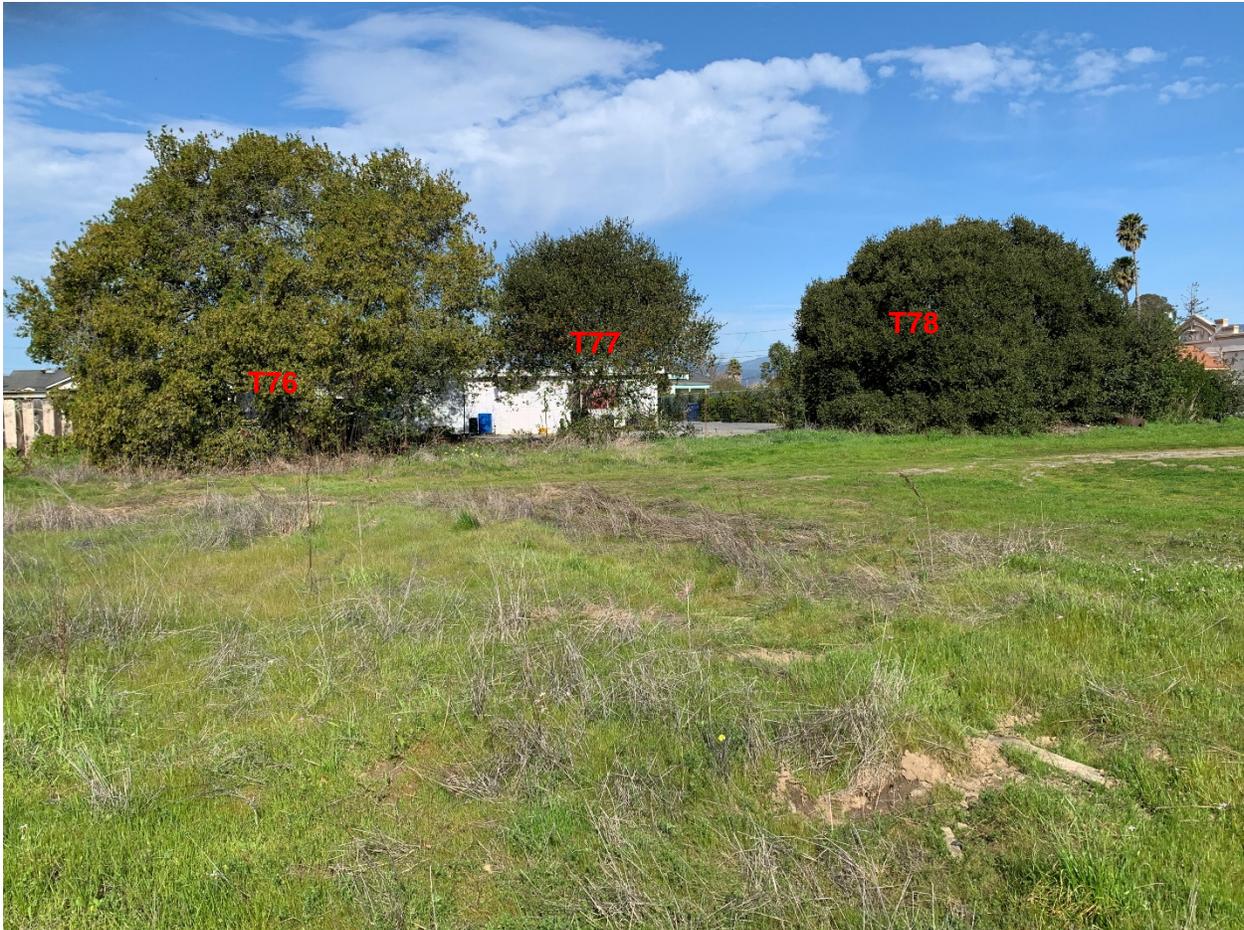
Three coast live oaks, trees T76-T78, were in a level area above and east of the grove, (Image #5). These trees were in either good or fair condition.

Image #5 – Trees T76-T78, coast live oak, growing in a row along the property line.

- Most of the trees are in good or fair condition.
- Ten trees including T50 privet and T54, T55, T58, T72, T73, T74, T76, T77 & T78 coast live oak, will require removal due to high construction impacts.

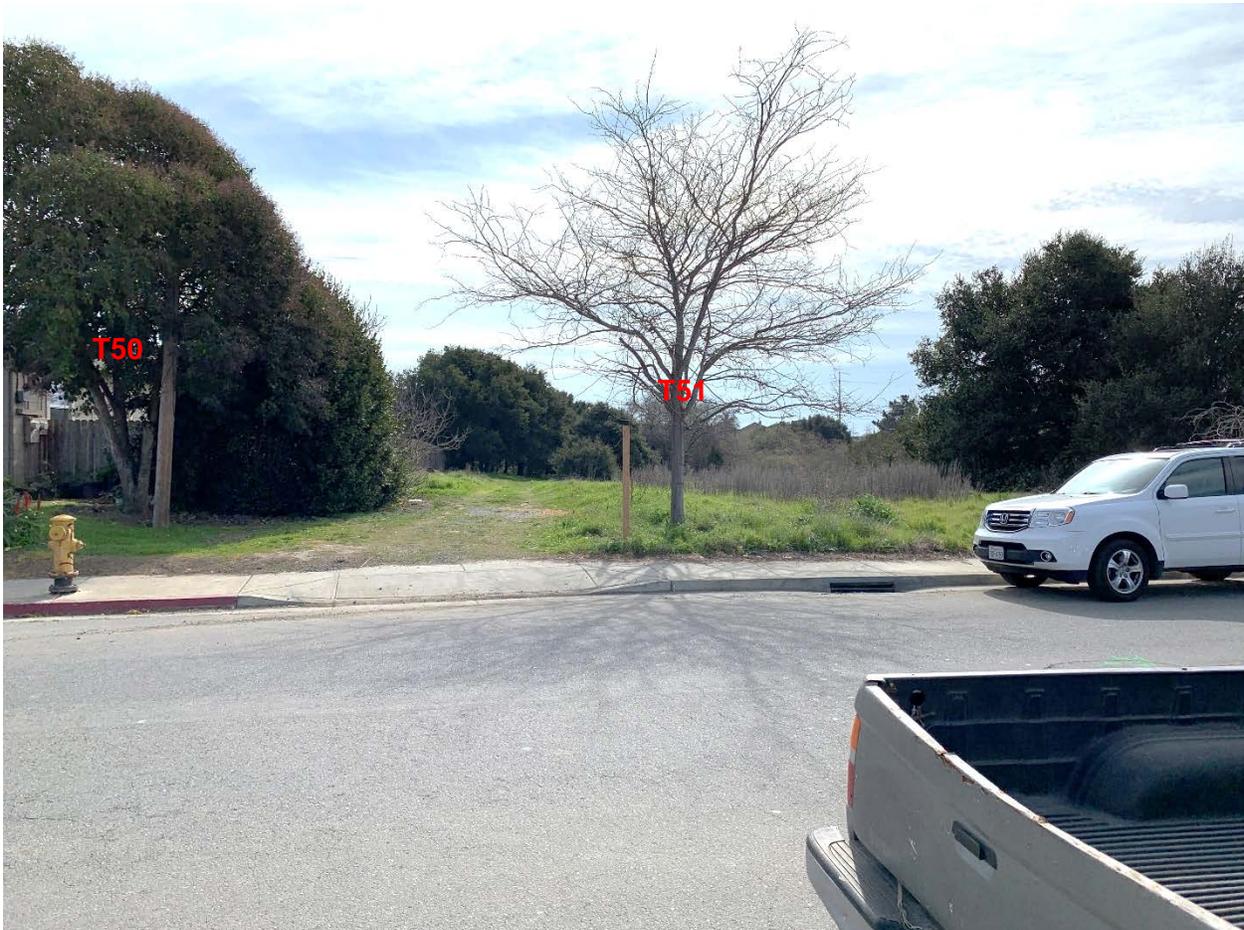
The three trees located adjacent to Atkinson Lane, T50-T52, included one in good condition, one in fair condition and one dead tree which has fallen (Image #6).

Image #6 – Trees T50 & T51, glossy privet and purple robe locust. A second locust, T52 (dead), to right of T51 has fallen and is not visible.

Four trees (3 coast live oak & 1 locust) should be removed due to poor condition. Oak tree T57 is nearly dead, oak T56 has minimal branching structure and live canopy, and oak T59 has minimal foliar canopy and is missing bark in the lower trunk. Tree T52 locust, is dead and has fallen.

- Four trees, T52 locust, T56, T57 and T59 coast live oak, are in poor condition and are not suitable for retention in the project.
- The impacts to most of the trees in the Watsonville parcel were not assessed since no site plan was available.

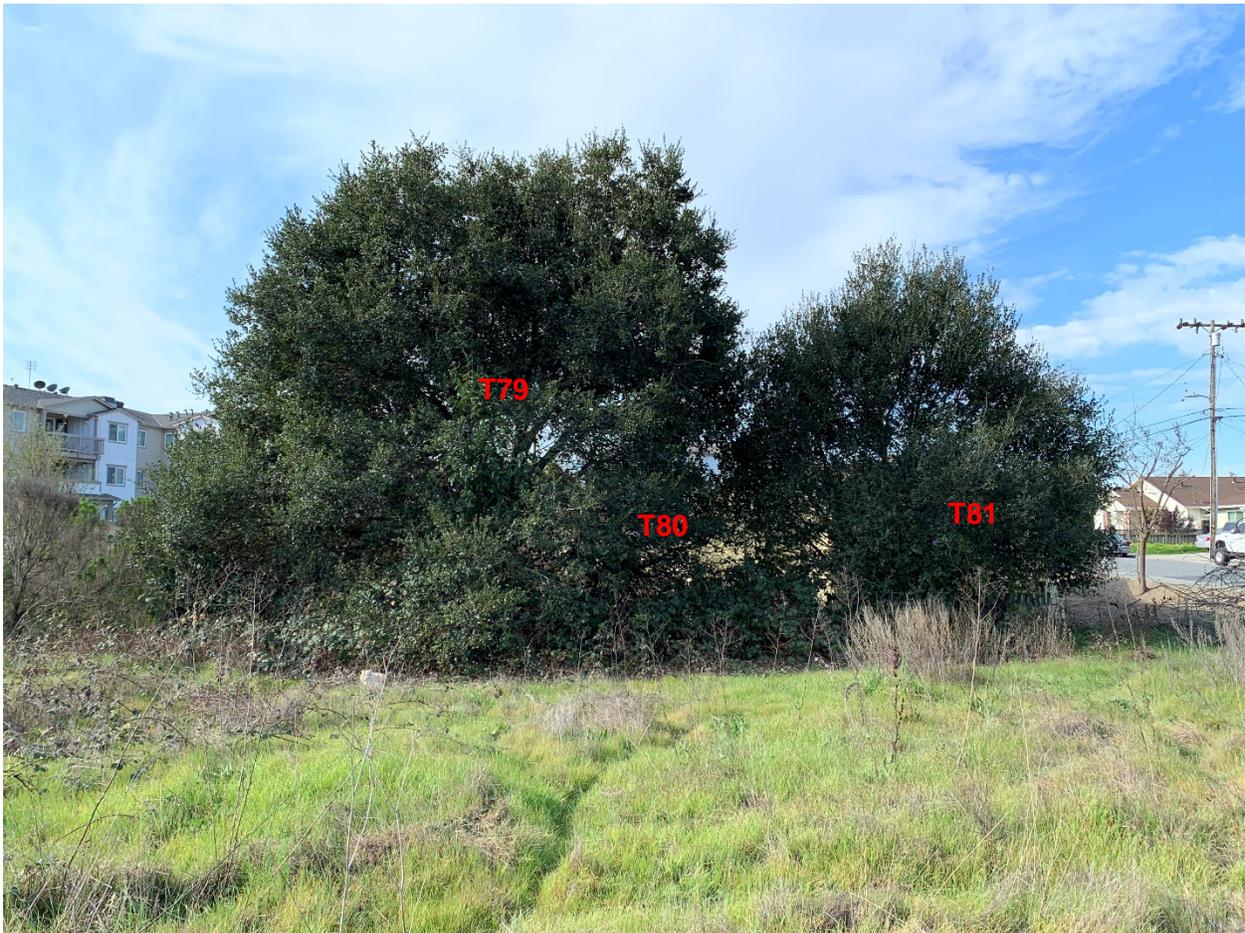
The three coast live oaks, trees T80-T82, are located on the southwestern edge of the Atkinson Lane parcel and were in either fair or good condition (Image #7).

Image #7 – Trees T79-T81, coast live oak, at southwest edge of Atkinson Lane parcel. Two trees T79 and T81 are in good condition. Tree T80 is in fair condition as its growth is suppressed by the two larger adjacent trees.
