ARBORIST REPORT-

Tree Inventory & Preliminary Impact Assessment
Atkinson Lane & Brewington Avenue, APN 048-221-09 & 091-236-01

Watsonville, CA

March 4, 2020

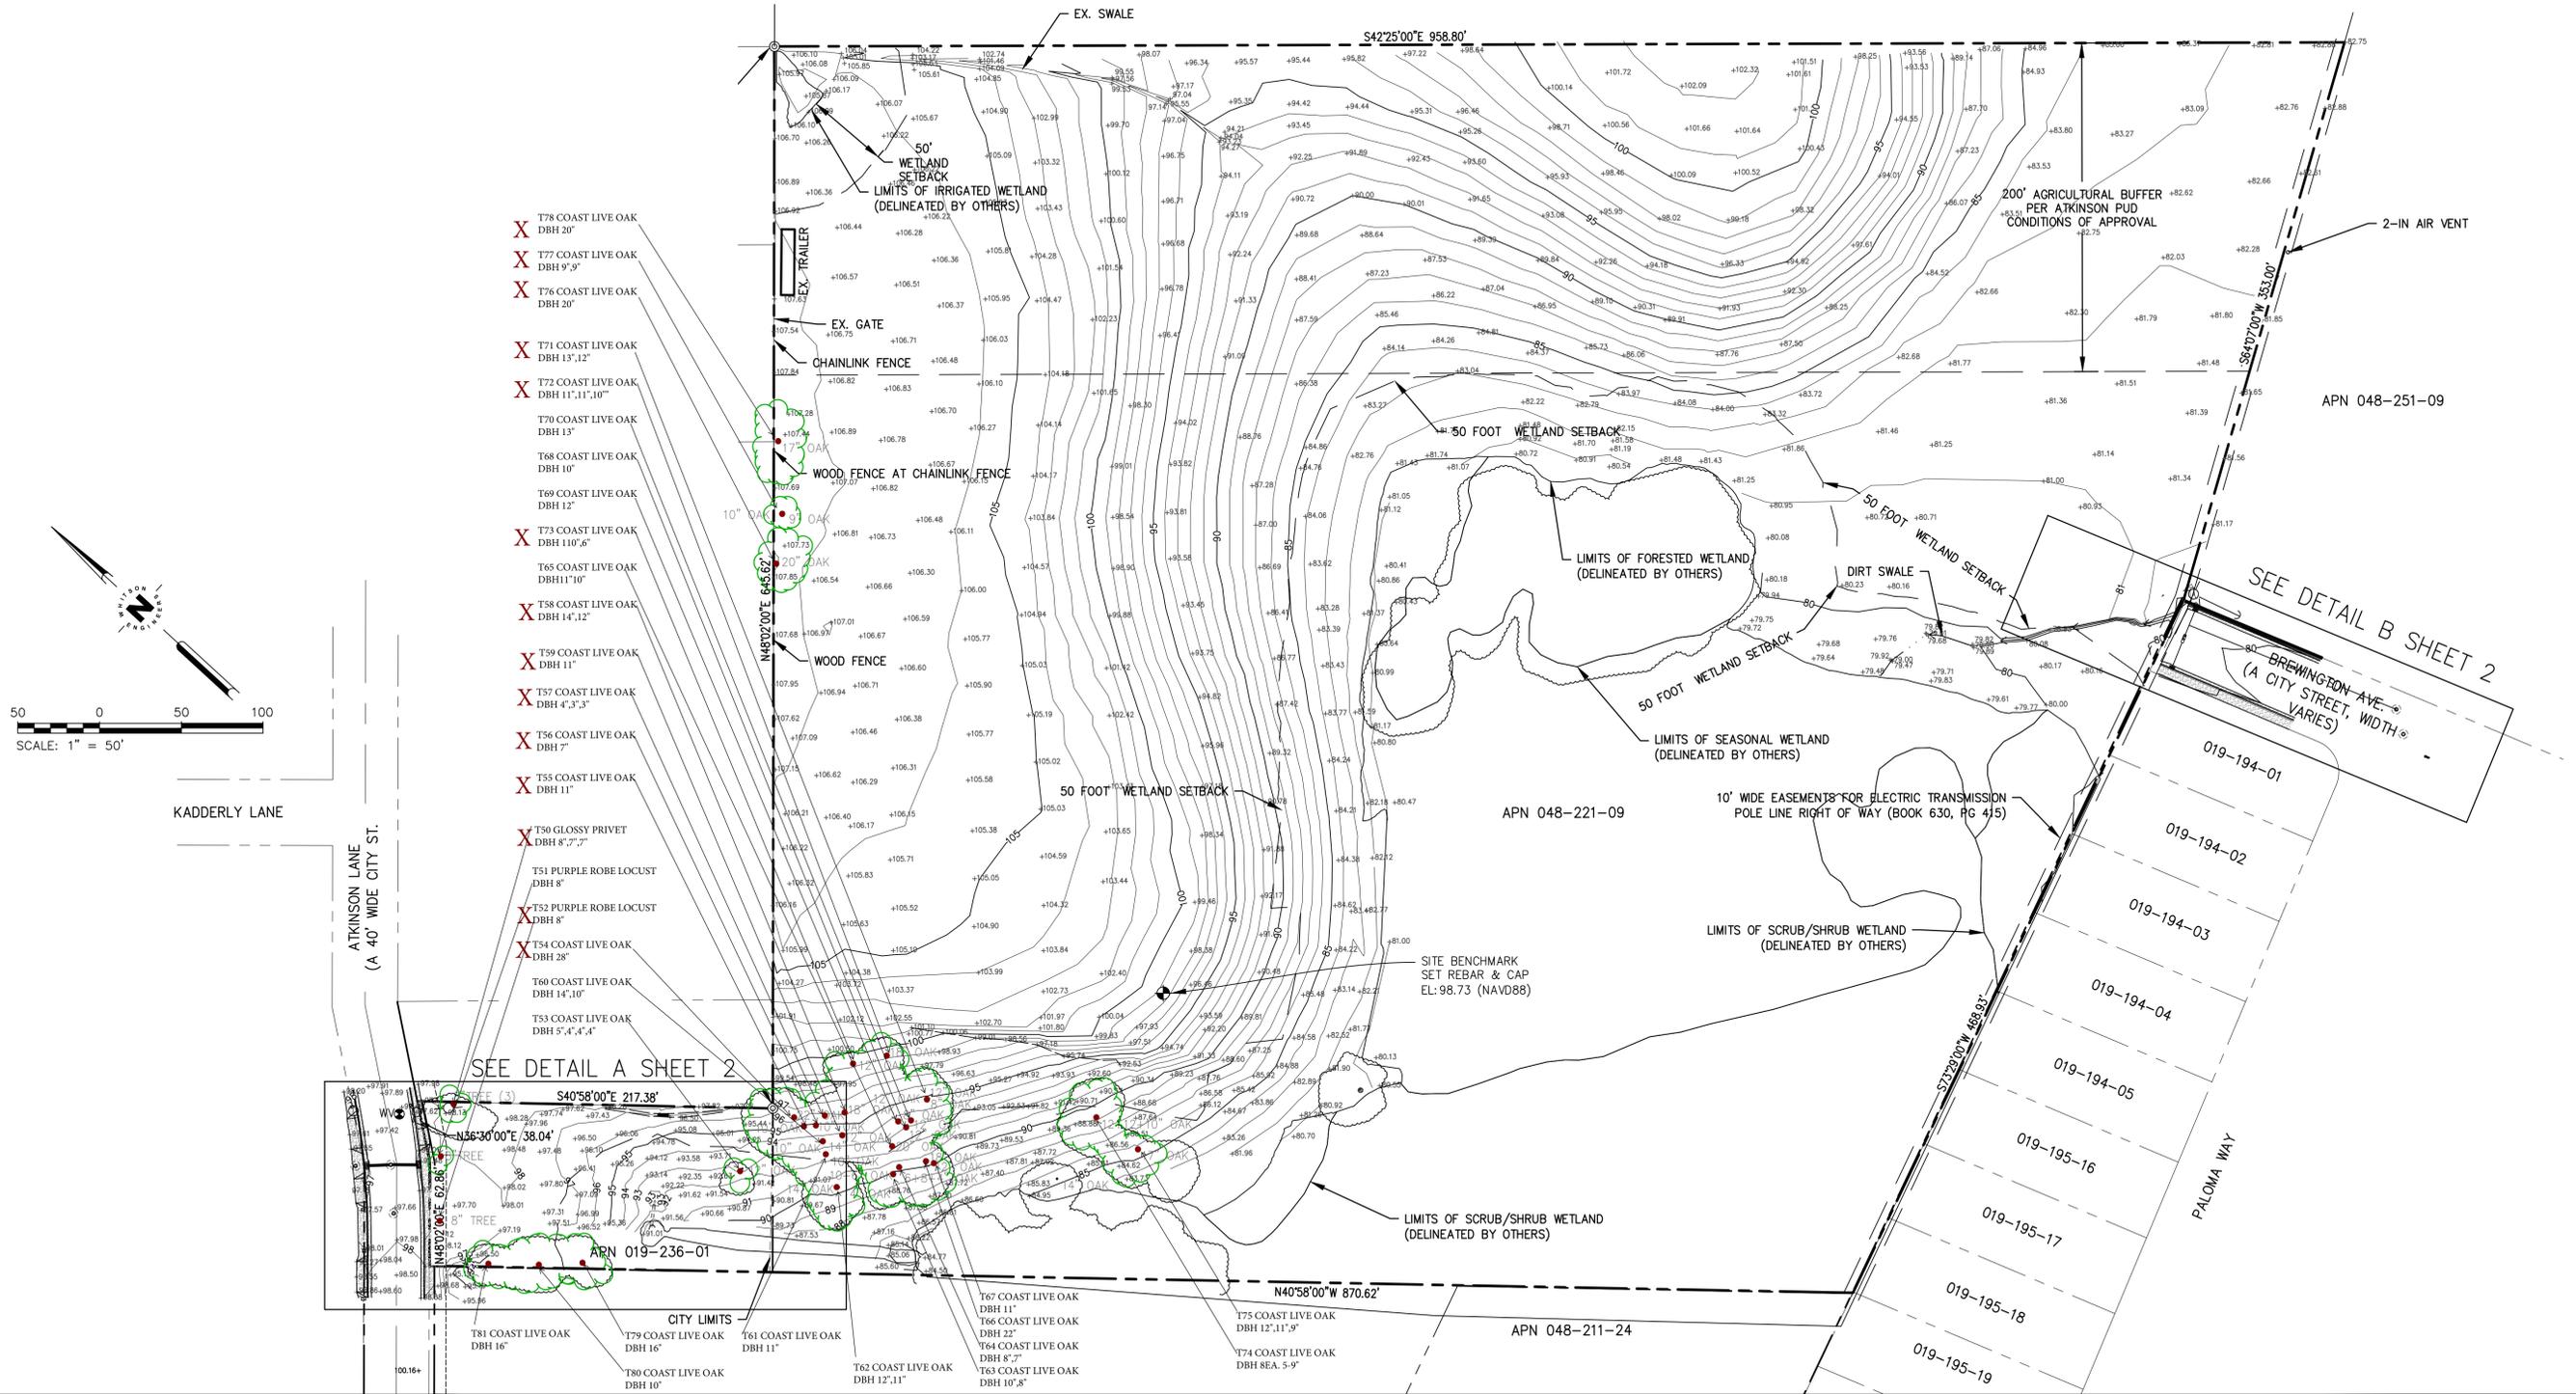
Appendix C - Tree Location Map

- X T78 COAST LIVE OAK
DBH 20"
- X T77 COAST LIVE OAK
DBH 9",9"
- X T76 COAST LIVE OAK
DBH 20"
- X T71 COAST LIVE OAK
DBH 13",12"
- X T72 COAST LIVE OAK
DBH 11",11",10"
- T70 COAST LIVE OAK
DBH 13"
- T68 COAST LIVE OAK
DBH 10"
- T69 COAST LIVE OAK
DBH 12"
- X T73 COAST LIVE OAK
DBH 110",6"
- T65 COAST LIVE OAK
DBH 11",10"
- X T58 COAST LIVE OAK
DBH 14",12"
- X T59 COAST LIVE OAK
DBH 11"
- X T57 COAST LIVE OAK
DBH 4",3",3"
- X T56 COAST LIVE OAK
DBH 7"
- X T55 COAST LIVE OAK
DBH 11"
- X T50 GLOSSY PRIVET
DBH 8",7",7"
- T51 PURPLE ROBE LOCUST
DBH 8"
- X T52 PURPLE ROBE LOCUST
DBH 8"
- X T54 COAST LIVE OAK
DBH 28"
- T60 COAST LIVE OAK
DBH 14",10"
- T55 COAST LIVE OAK
DBH 5",4",4",4"
