**No Project
Time Sequence of Erosion**

Santa Cruz, California

Figure 6-5

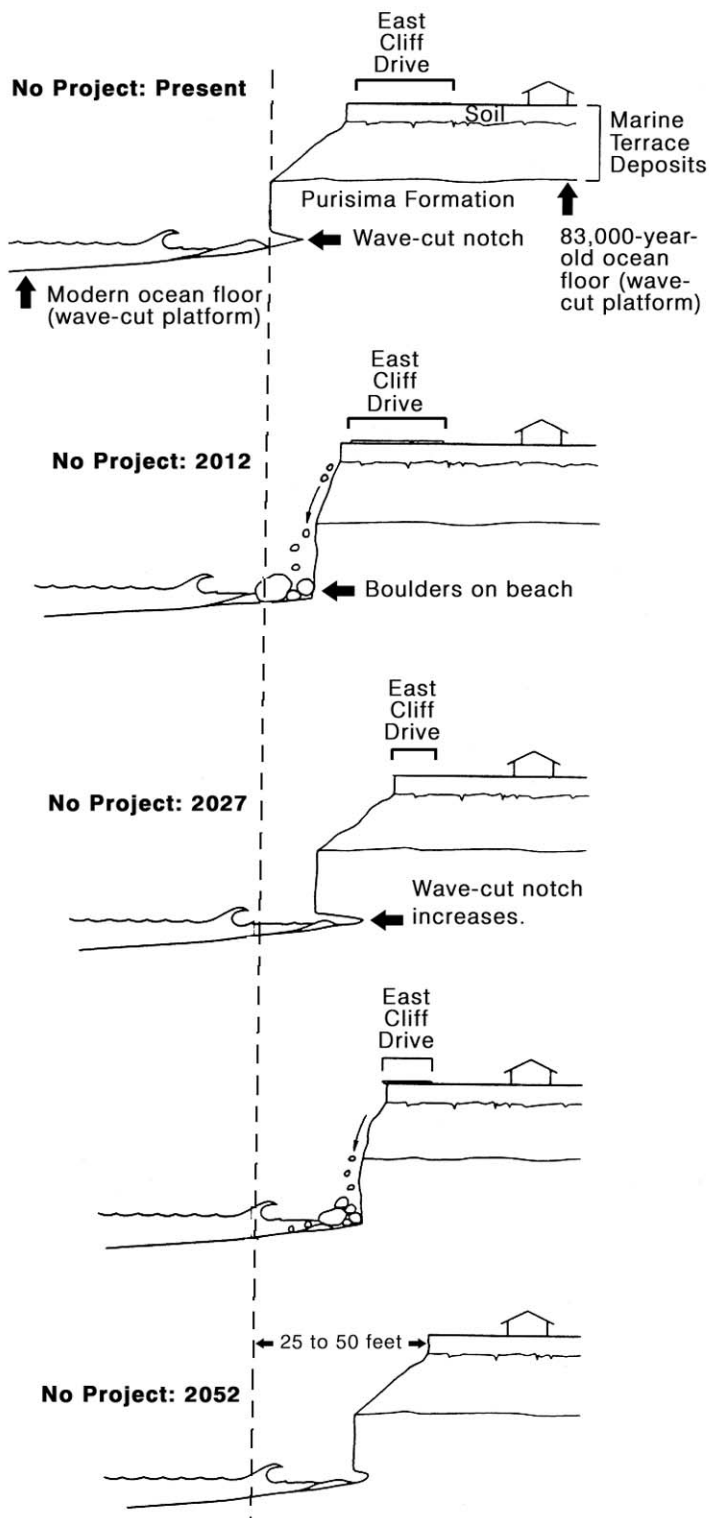
Stage 1

Cliff formed in the terrace deposits is nearing equilibrium, as indicated by the low slope angle. Lower half of cliff formed in the Purisima Formation is being undercut by wave erosion. Portions of East Cliff Drive are now in this condition.

Interlude A

Wave erosion continues to undercut cliff to the point where it will collapse. Top of the cliff is experiencing little, if any, erosion.

Stage 2

Undercut cliff collapses. A large mass of debris is deposited in the surf zone and must be removed by wave action. Cliff is now vertical. While wave erosion removes debris from surf zone, the upper half of the cliff now begins to weather and fail as a series of small landslides. East Cliff threatened.

Interlude B

Continued failure of the top of the cliff undermines portions of East Cliff Drive. Portions of the road must be closed. The debris from the rock fall of Stage 2 is now completely removed by erosion.

Stage 3

Erosion continues to cut back top of slope. Almost half of East Cliff Drive eroded away. Undercut notch deeper. Cliff ready to collapse. Note similarity of the cliff profile to Stage 1.

Interlude C

Erosion continues at both the top and the base of the cliff, but undercutting by wave erosion causes cliff to collapse.

Stage 4

Cliff has collapsed. Once again a large mass of debris has been deposited in the surf zone. Cliff is once again nearly vertical. Note similarity to Stage 2. East Cliff Drive is at the top of a steep cliff.

Interlude D

Wave erosion removes rock debris from the surf zone, while the terrace deposits experience a phase of accelerated erosion. Upper portion of cliff face experiences rapid retreat.
